TEST REPORT

N° RP LS 19/164A

DEVICES UNDER TEST: Shrinkable indoor/outdoor terminations for cables

TYPES: ELCOTERM TIS – 2482X/W-3X1-NL-03
ELCOTERM TES – 2484X/W-3X1-NL-03

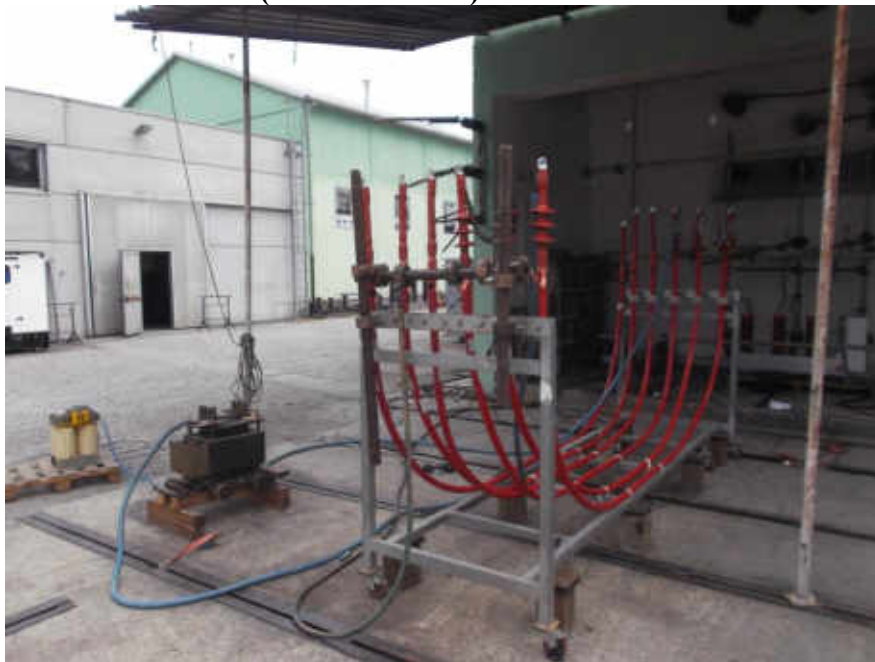
Photo 1: arrangement for heating cables

Before the tests the cables were heated to a stabilized temperature on main conductor of extruded cables of 95 – 97°C and kept for two hours at this temperature. The corresponding temperature on sheath at above cable temperature was 73 °C with ambient temperature of 28-30 °C (to see photo nr. 1 and photo no. 12). The setting of temperature was determined by one thermocouple applied in the sheath of the cable, at 0,5 meter of the terminals under test.

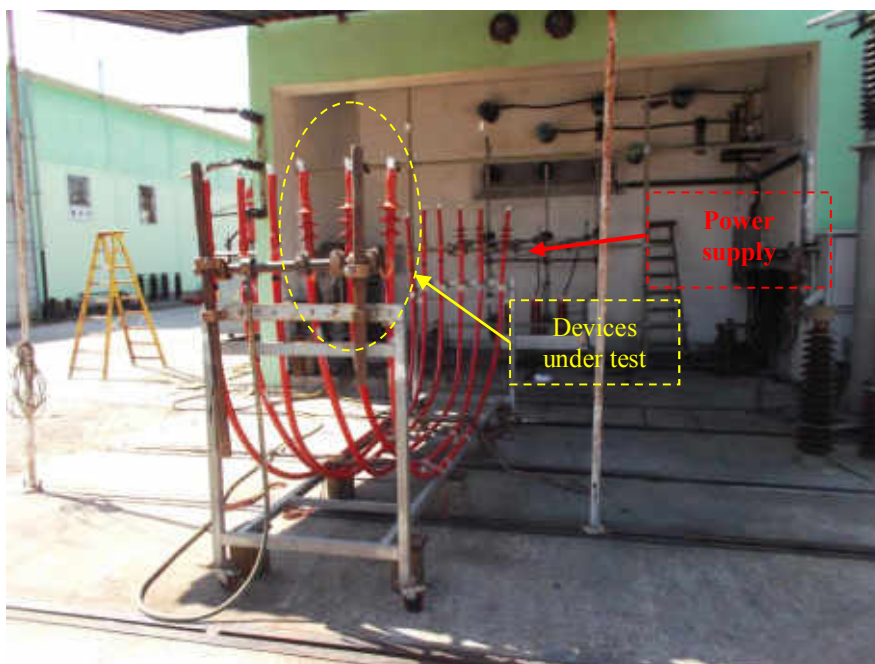
Photo 2: arrangement for thermal short-circuit test on screen/armour

The cables of test sets were fixed to the supporting structure by means some anchor systems. The three-phase power supply was applied between the three terminals of the screen, the screen terminals under test were connected to the short-circuit at ground point. For test arrangement see photo nr. 2.

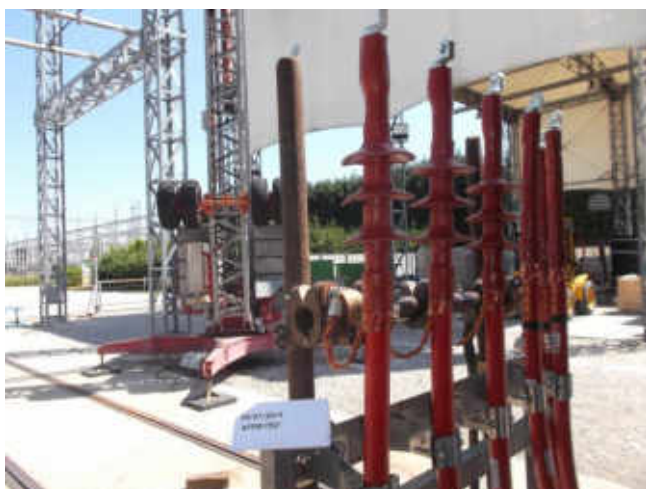
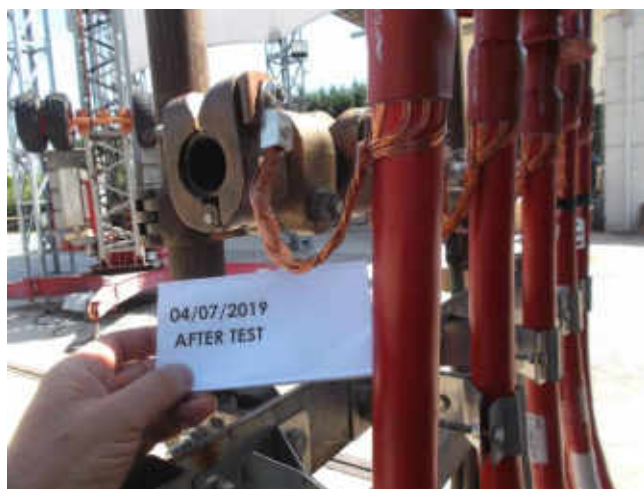
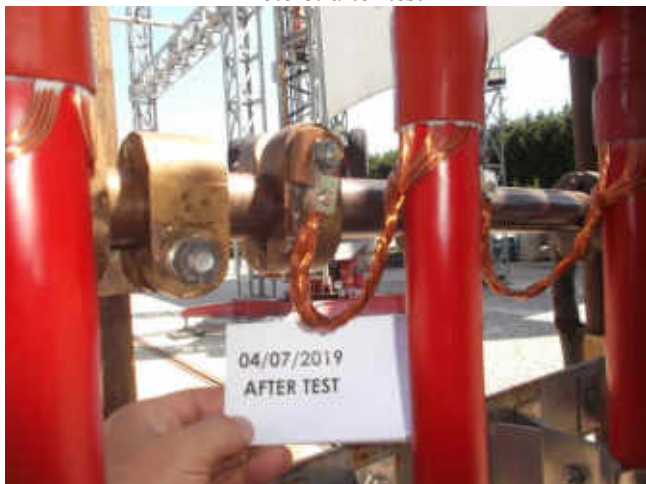
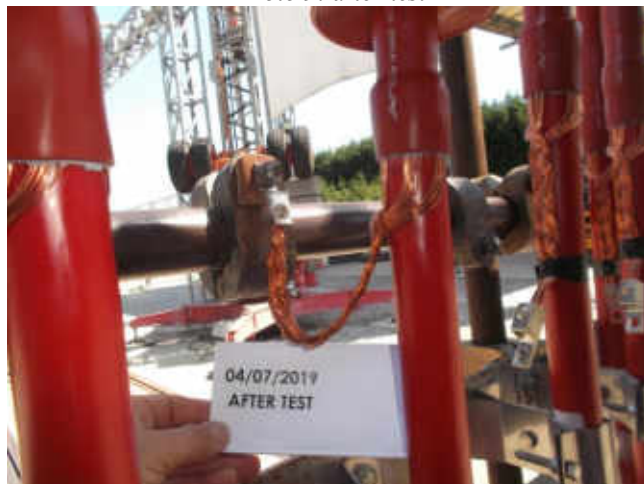
Photo 8: after test

Photo 9: after test

Photo 10: after test

Photo 11: after test

A visual inspection did not show deteriorations on terminals screen (to see photos nr. 8 to 11).

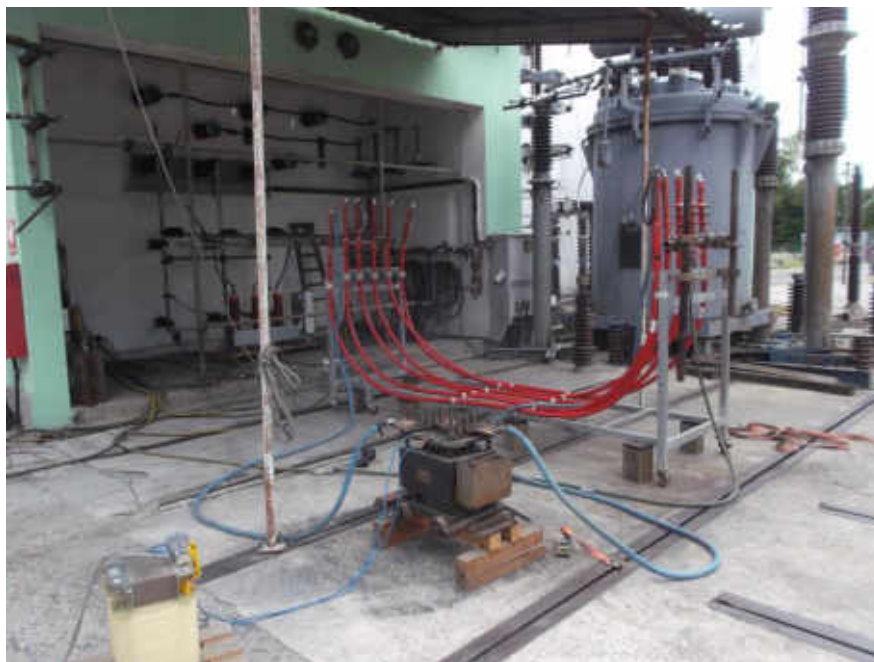
Photo 12: arrangement for heating cables

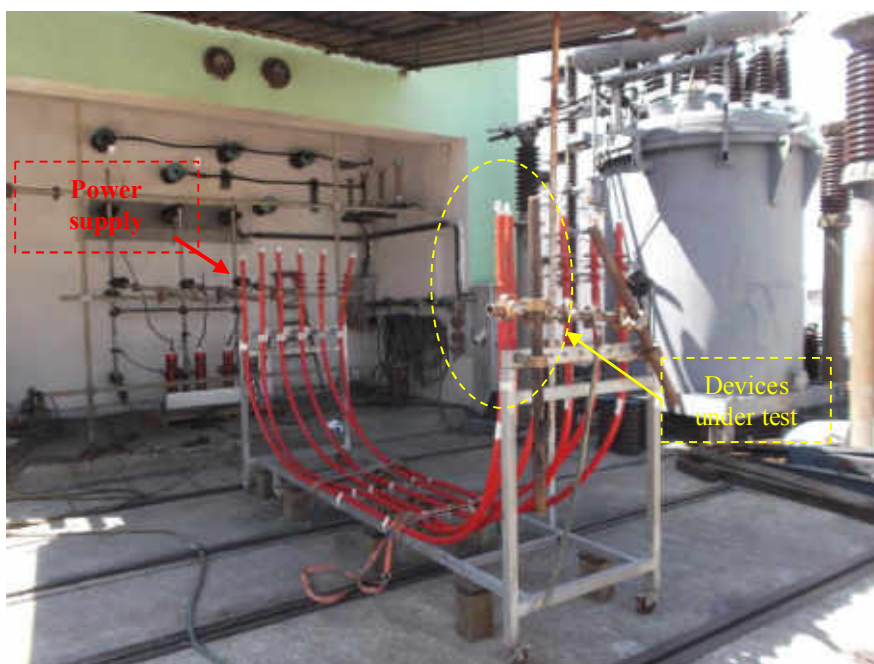
Photo 13: arrangement for thermal short-circuit test on screen/armour

The cables of test sets were fixed to the supporting structure by means some anchor systems. The three-phase power supply was applied between the three terminals of the screen, the screen terminals under test were connected to the short-circuit at ground point. See photo nr. 13.

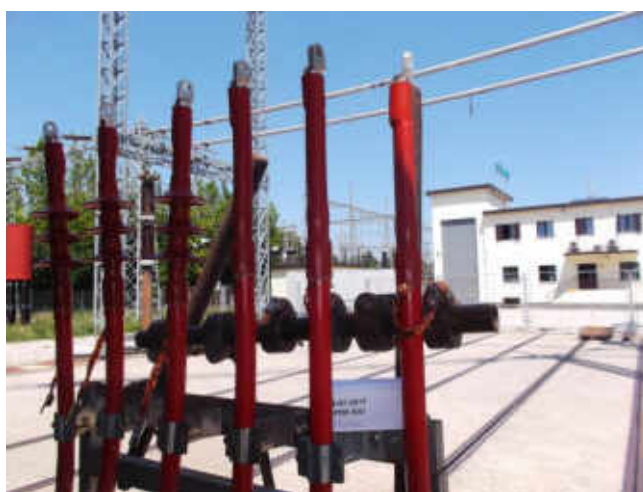
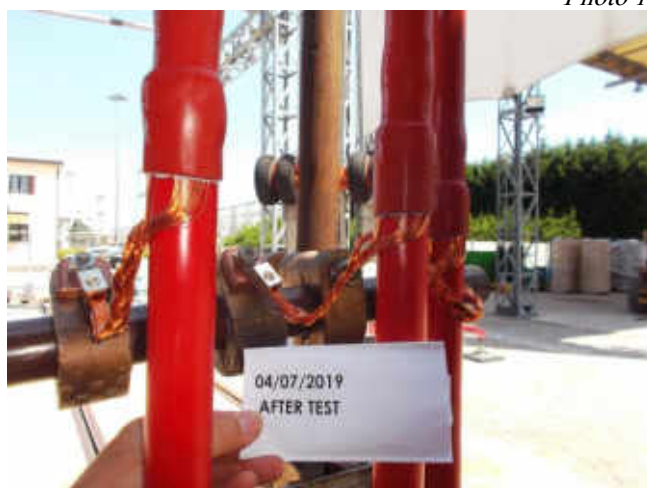
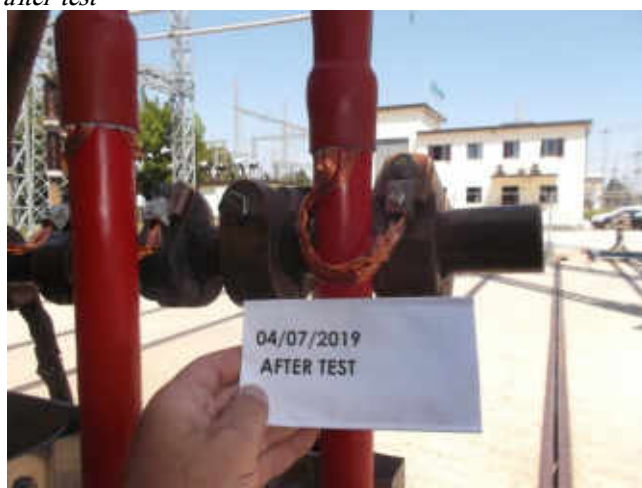
Photo 18: after test

Photo 19: after test

Photo 20: after test

A visual inspection did not show deteriorations on terminals screen (to see photos nr.18 to 20).

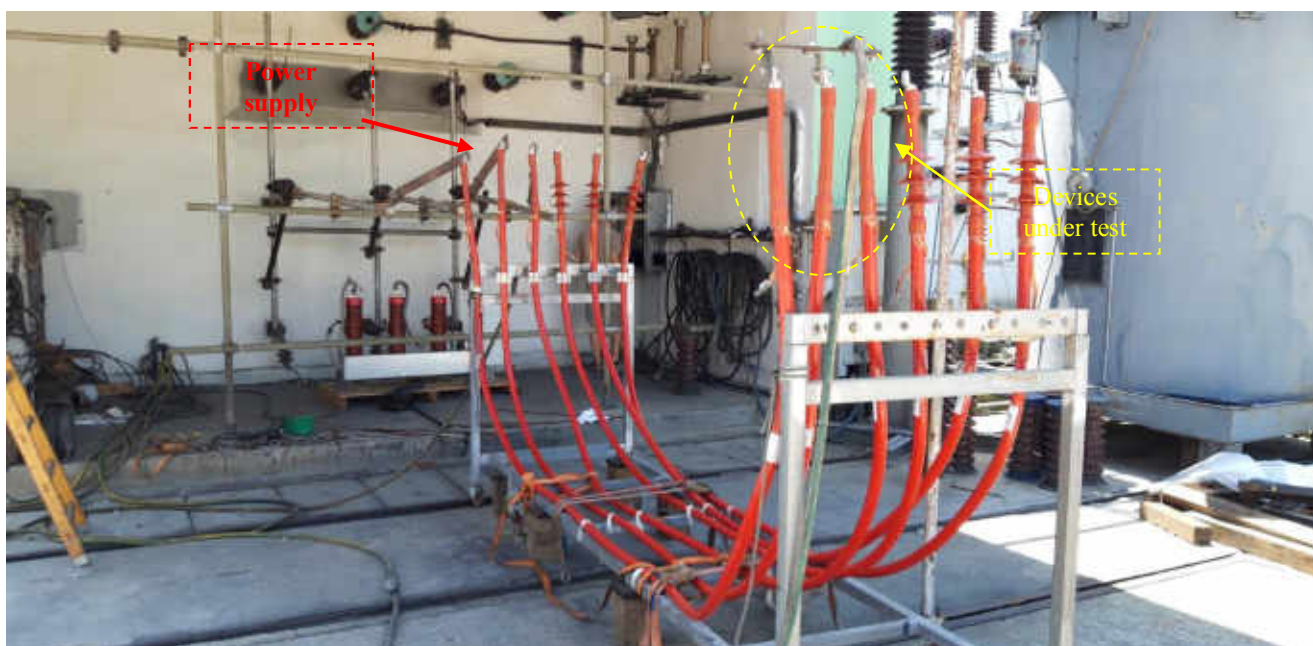
Photo 21: arrangement test

The cables of test sets were fixed to the supporting structure by means some anchor systems. The three-phase power supply was applied between the three terminals of the conductor, the conductor terminals under test were connected to the short-circuit at ground point. See photos nr. 21

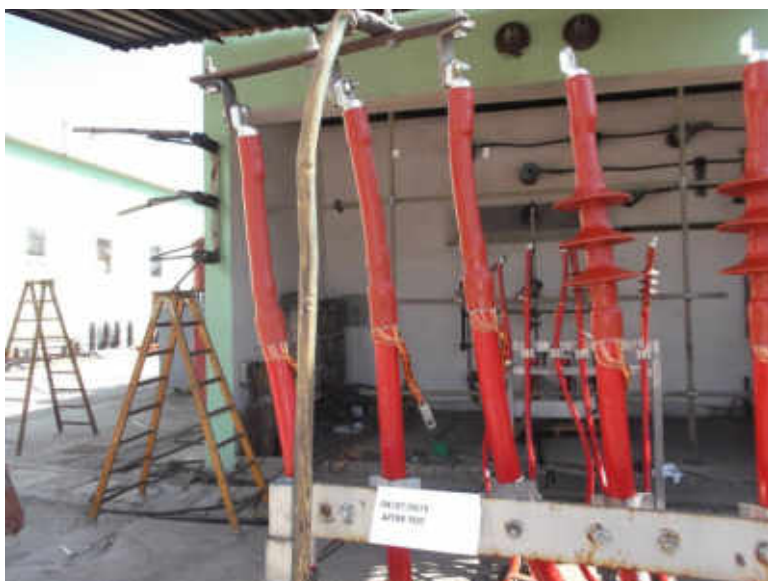
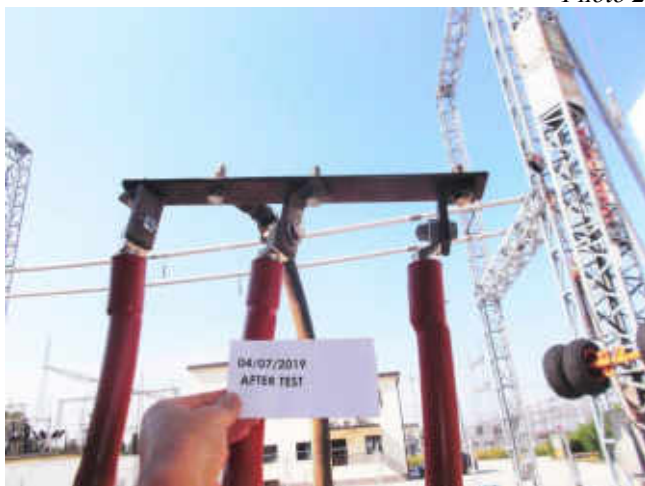
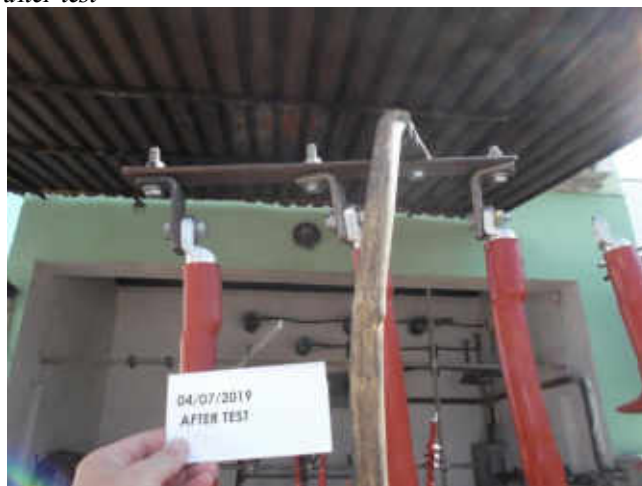
Photo 25: after test

Photo 26: after test

Photo 27: after test

A visual inspection did not show deteriorations on terminals conductor (to see photos nr.25 to 27).

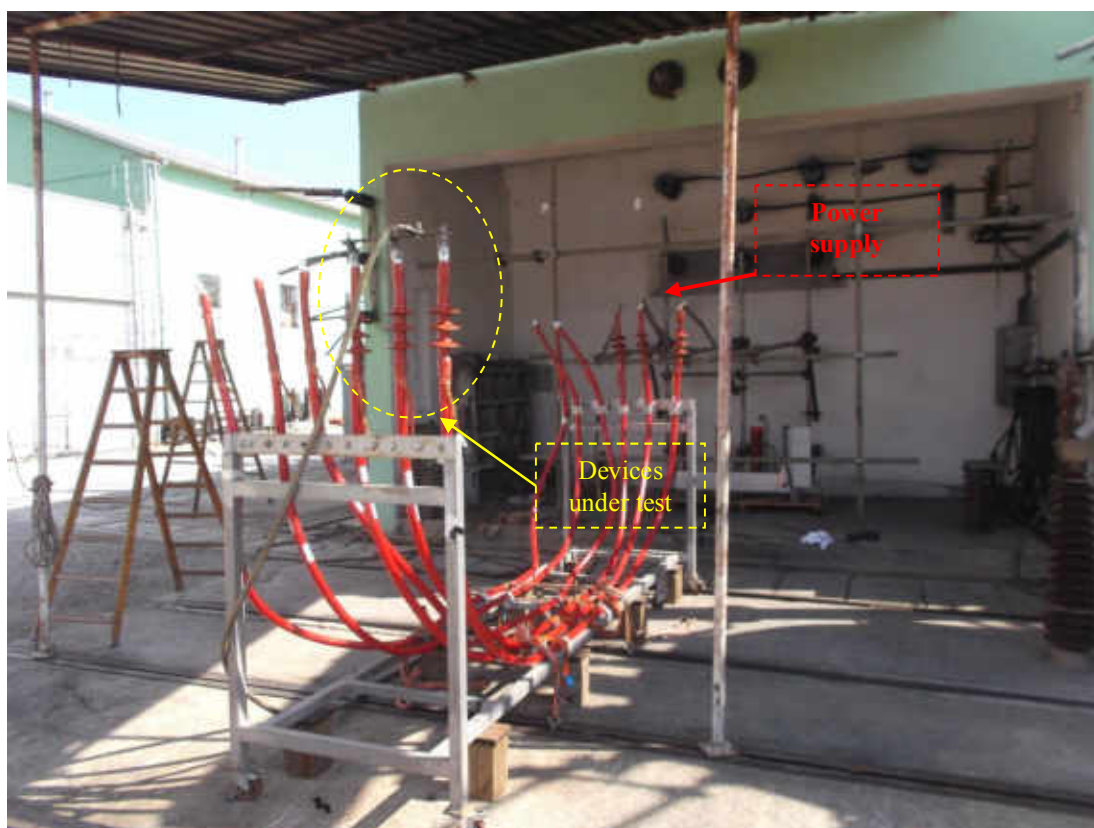
Photo 28: arrangement test

The cables of test sets were fixed to the supporting structure by means some anchor systems. The three-phase power supply was applied between the three terminals of the conductor, the conductor terminals under test were connected to the short-circuit at ground point. See photos nr. 28.

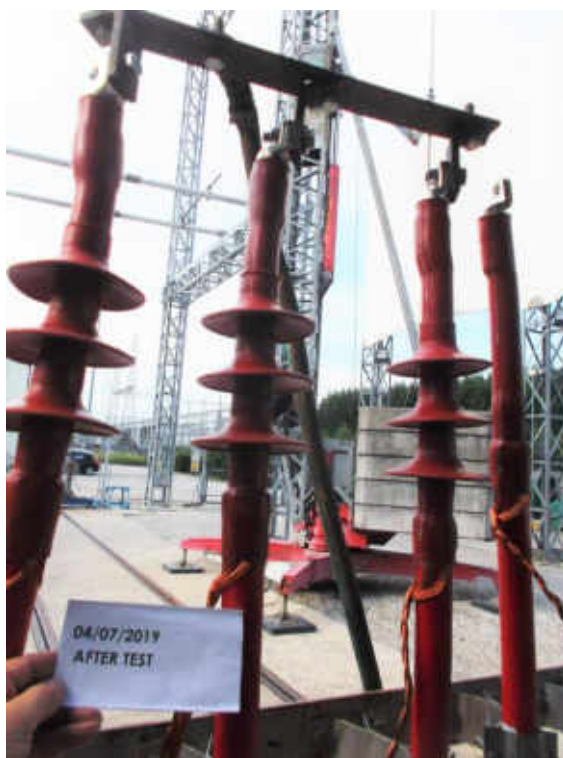
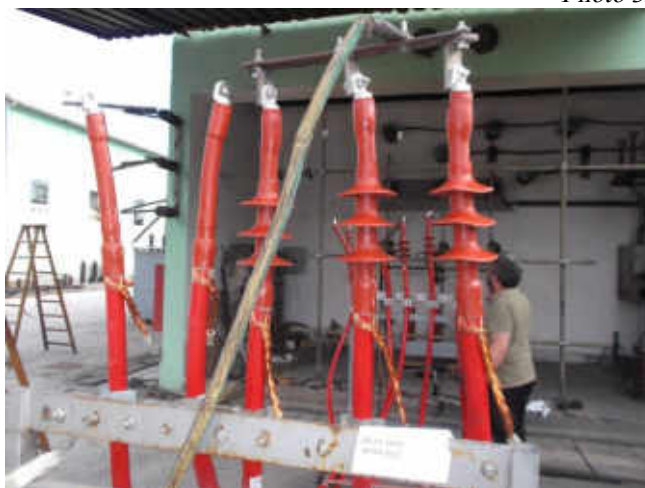
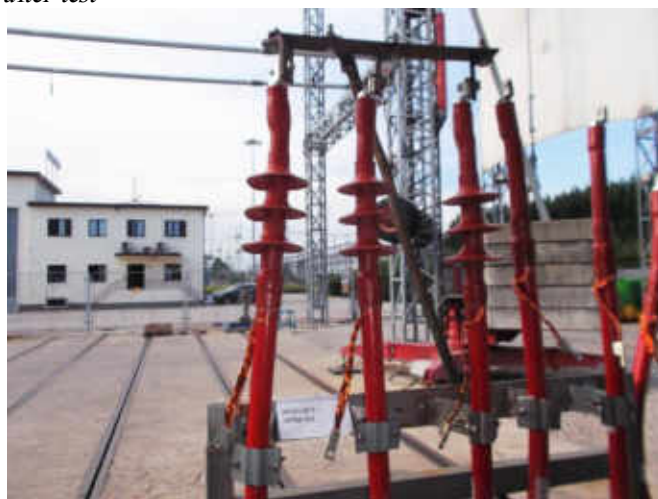
Photo 32: after test

Photo 33: after test

Photo 34: after test

A visual inspection did not show deteriorations on terminals conductor (to see photos nr.32 to 34).

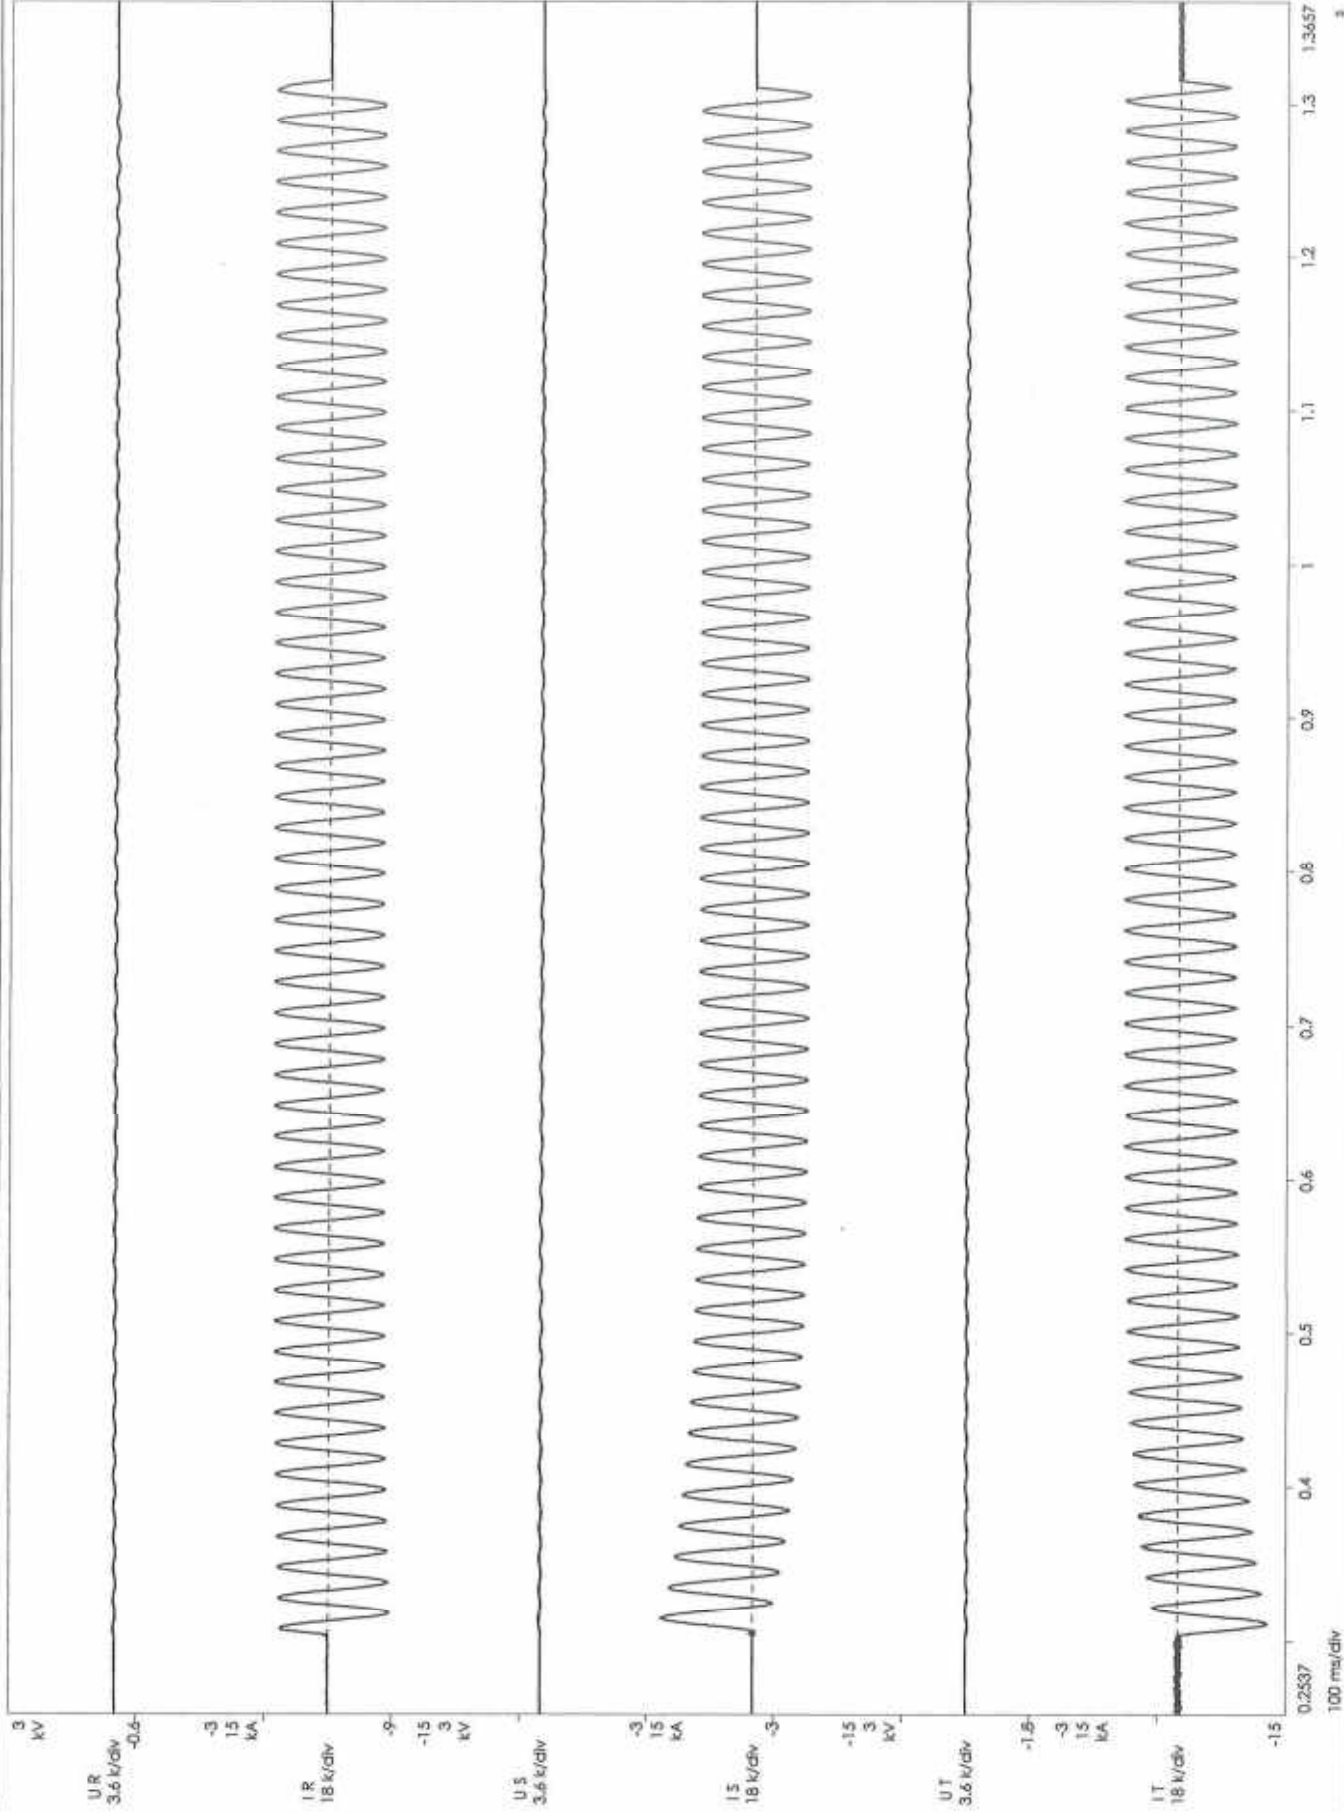
test current

phase R	
R.M.S. value	5.5 kA
peak value	8.6 kA
phase S	
R.M.S. value	5.4 kA
peak value	13.0 kA
phase T	
R.M.S. value	5.5 kA
peak value	12.5 kA
mean value	5.5 kA
duration	1.011 s
i^2t	30 (kA) ² s

1 amb = 29.4 °C

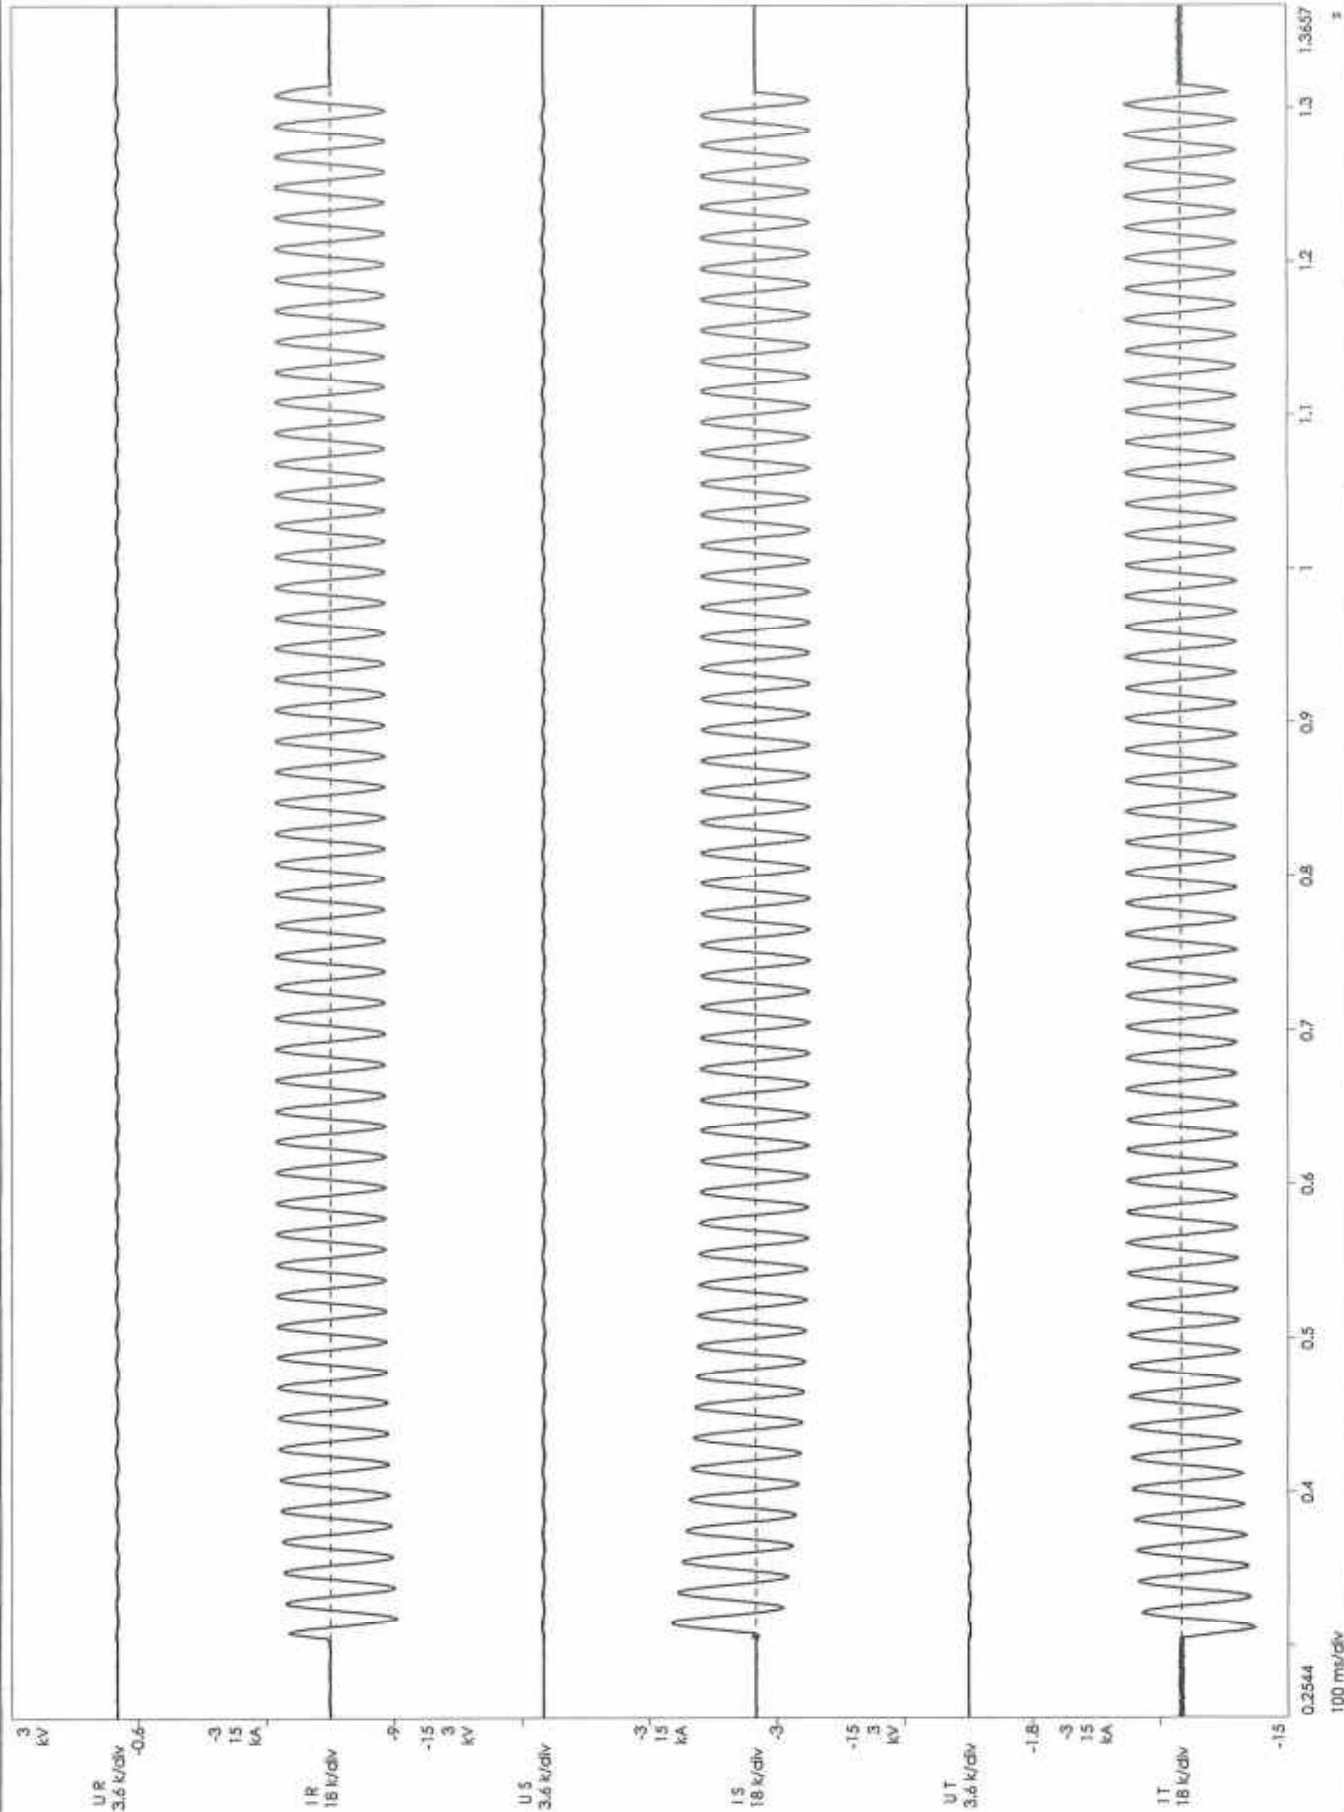
test current

phase R	
R.M.S. value	5.5 kA
peak value	9.4 kA
phase S	
R.M.S. value	5.4 kA
peak value	11.9 kA
phase T	
R.M.S. value	5.5 kA
peak value	10.4 kA
mean value	5.5 kA
duration	1.010 s
I^2t	30 (kA) ² s

$t_{amb} = 30.0 ^\circ\text{C}$

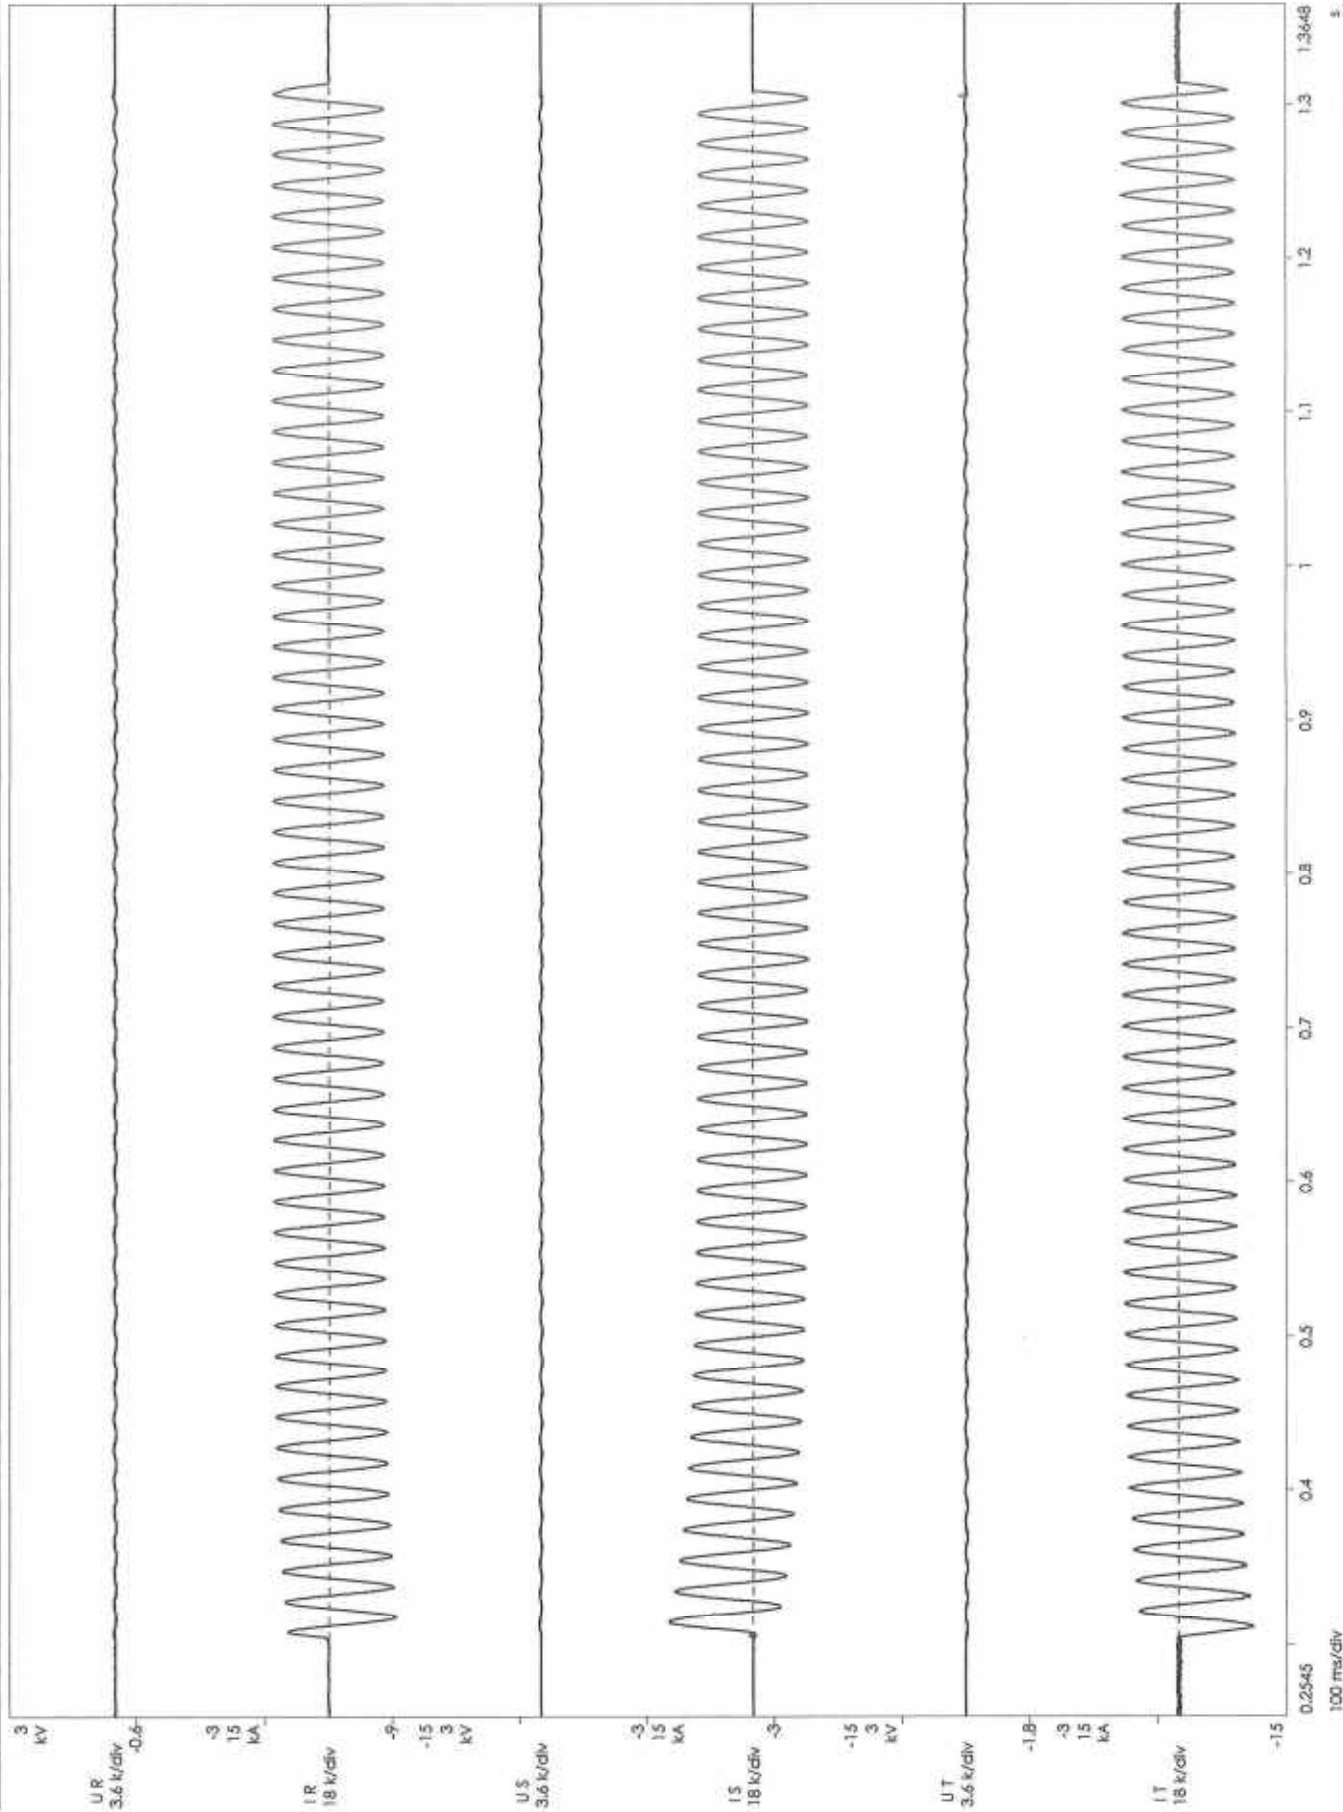
test current

phase R	
R.M.S. value	5.5 kA
peak value	9.5 kA
phase S	
R.M.S. value	5.4 kA
peak value	11.9 kA
phase T	
R.M.S. value	5.6 kA
peak value	10.4 kA
mean value	5.5 kA
duration	1.009 s
i_2	30 (kA) ² s

$t_{amb} = 30.0\text{ }^{\circ}\text{C}$

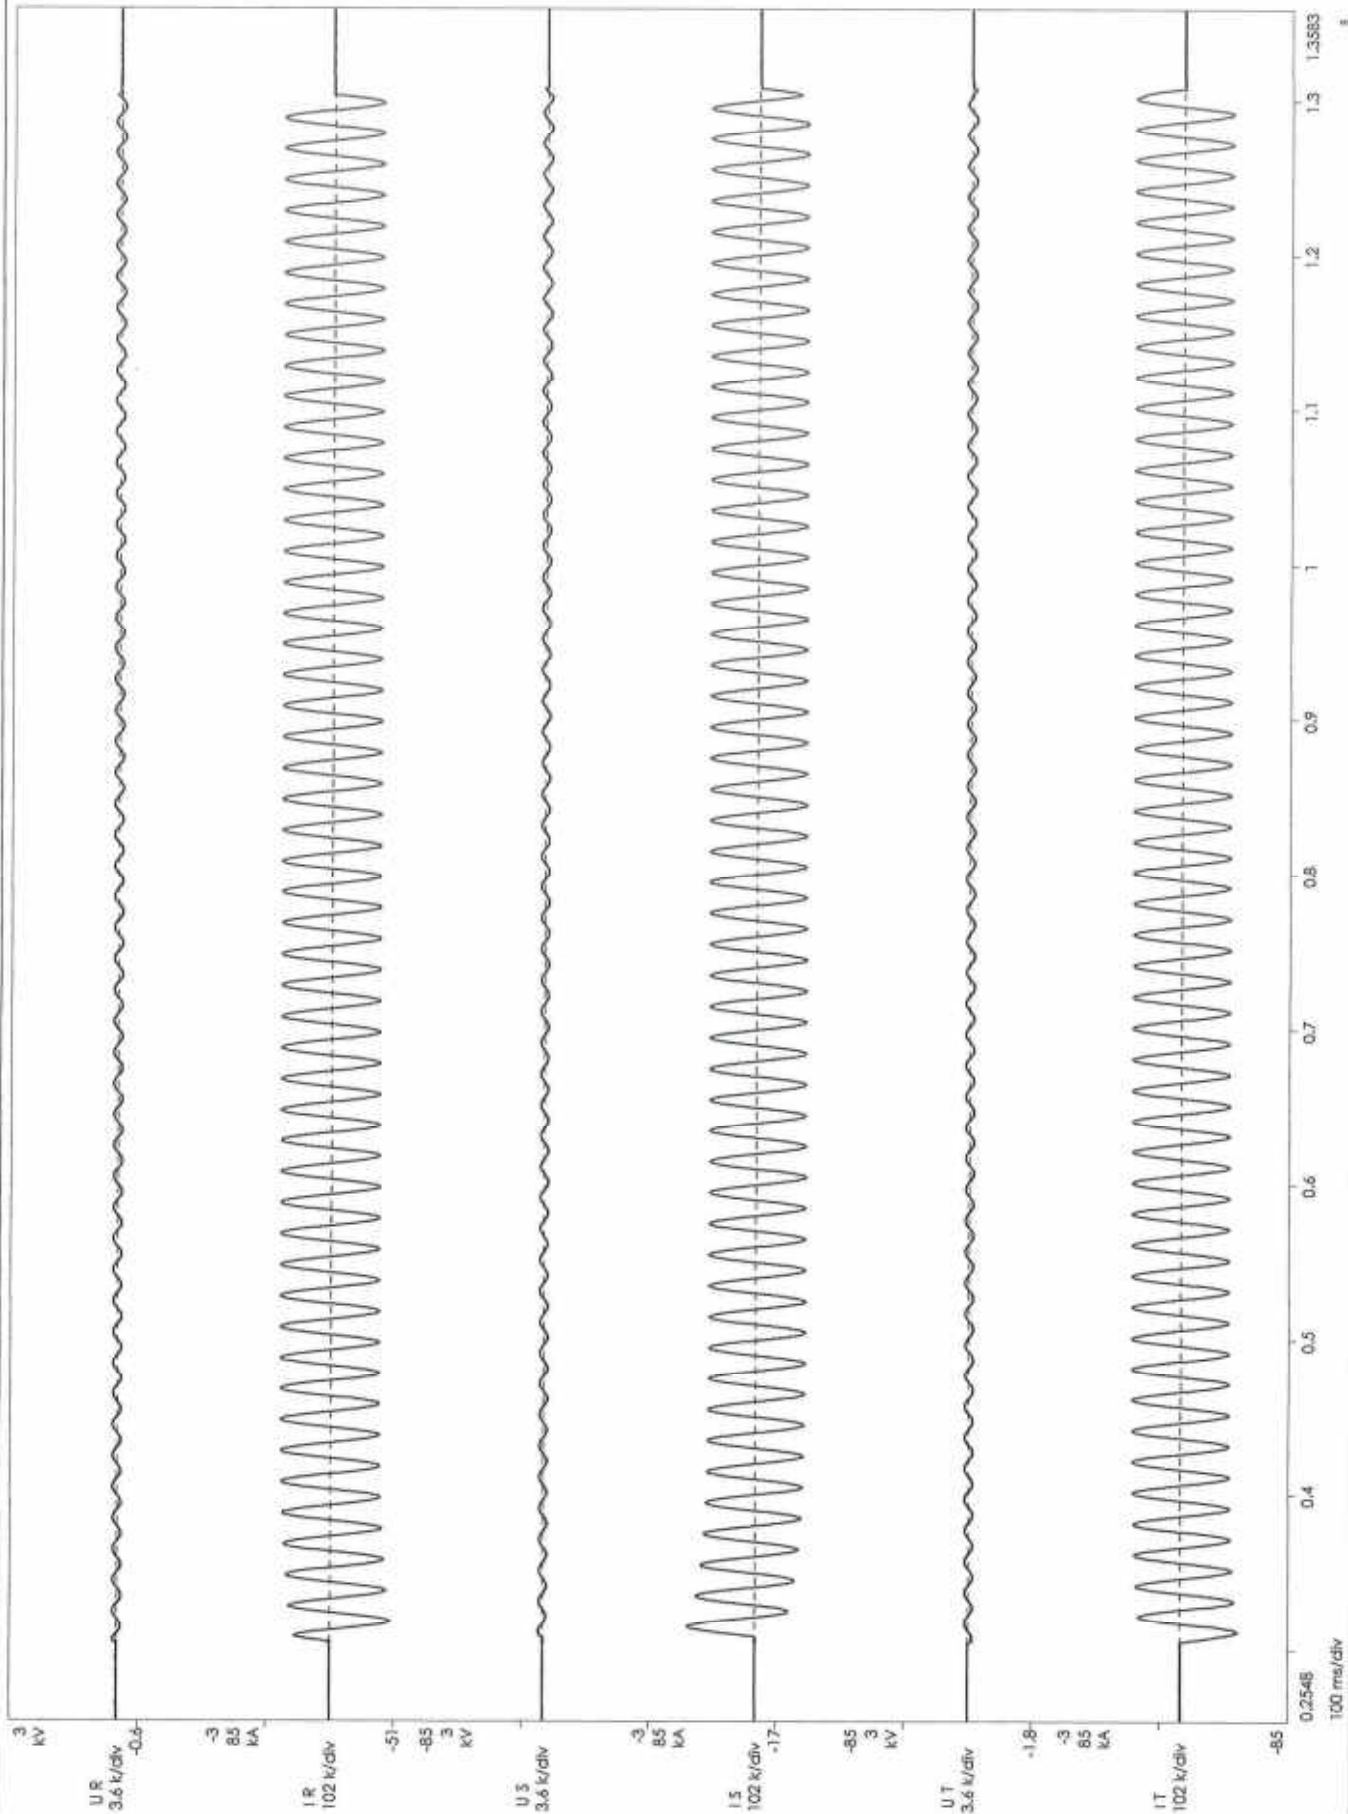
test current

phase R	
R.M.S. value	28.3 kA
peak value	47.9 kA
phase S	
R.M.S. value	27.8 kA
peak value	53.8 kA
phase T	
R.M.S. value	27.9 kA
peak value	45.2 kA
mean value	28.0 kA
duration	1.003 s
I_{R1}	786 (kA) ² s

$T_{amb} = 31.0^{\circ}\text{C}$

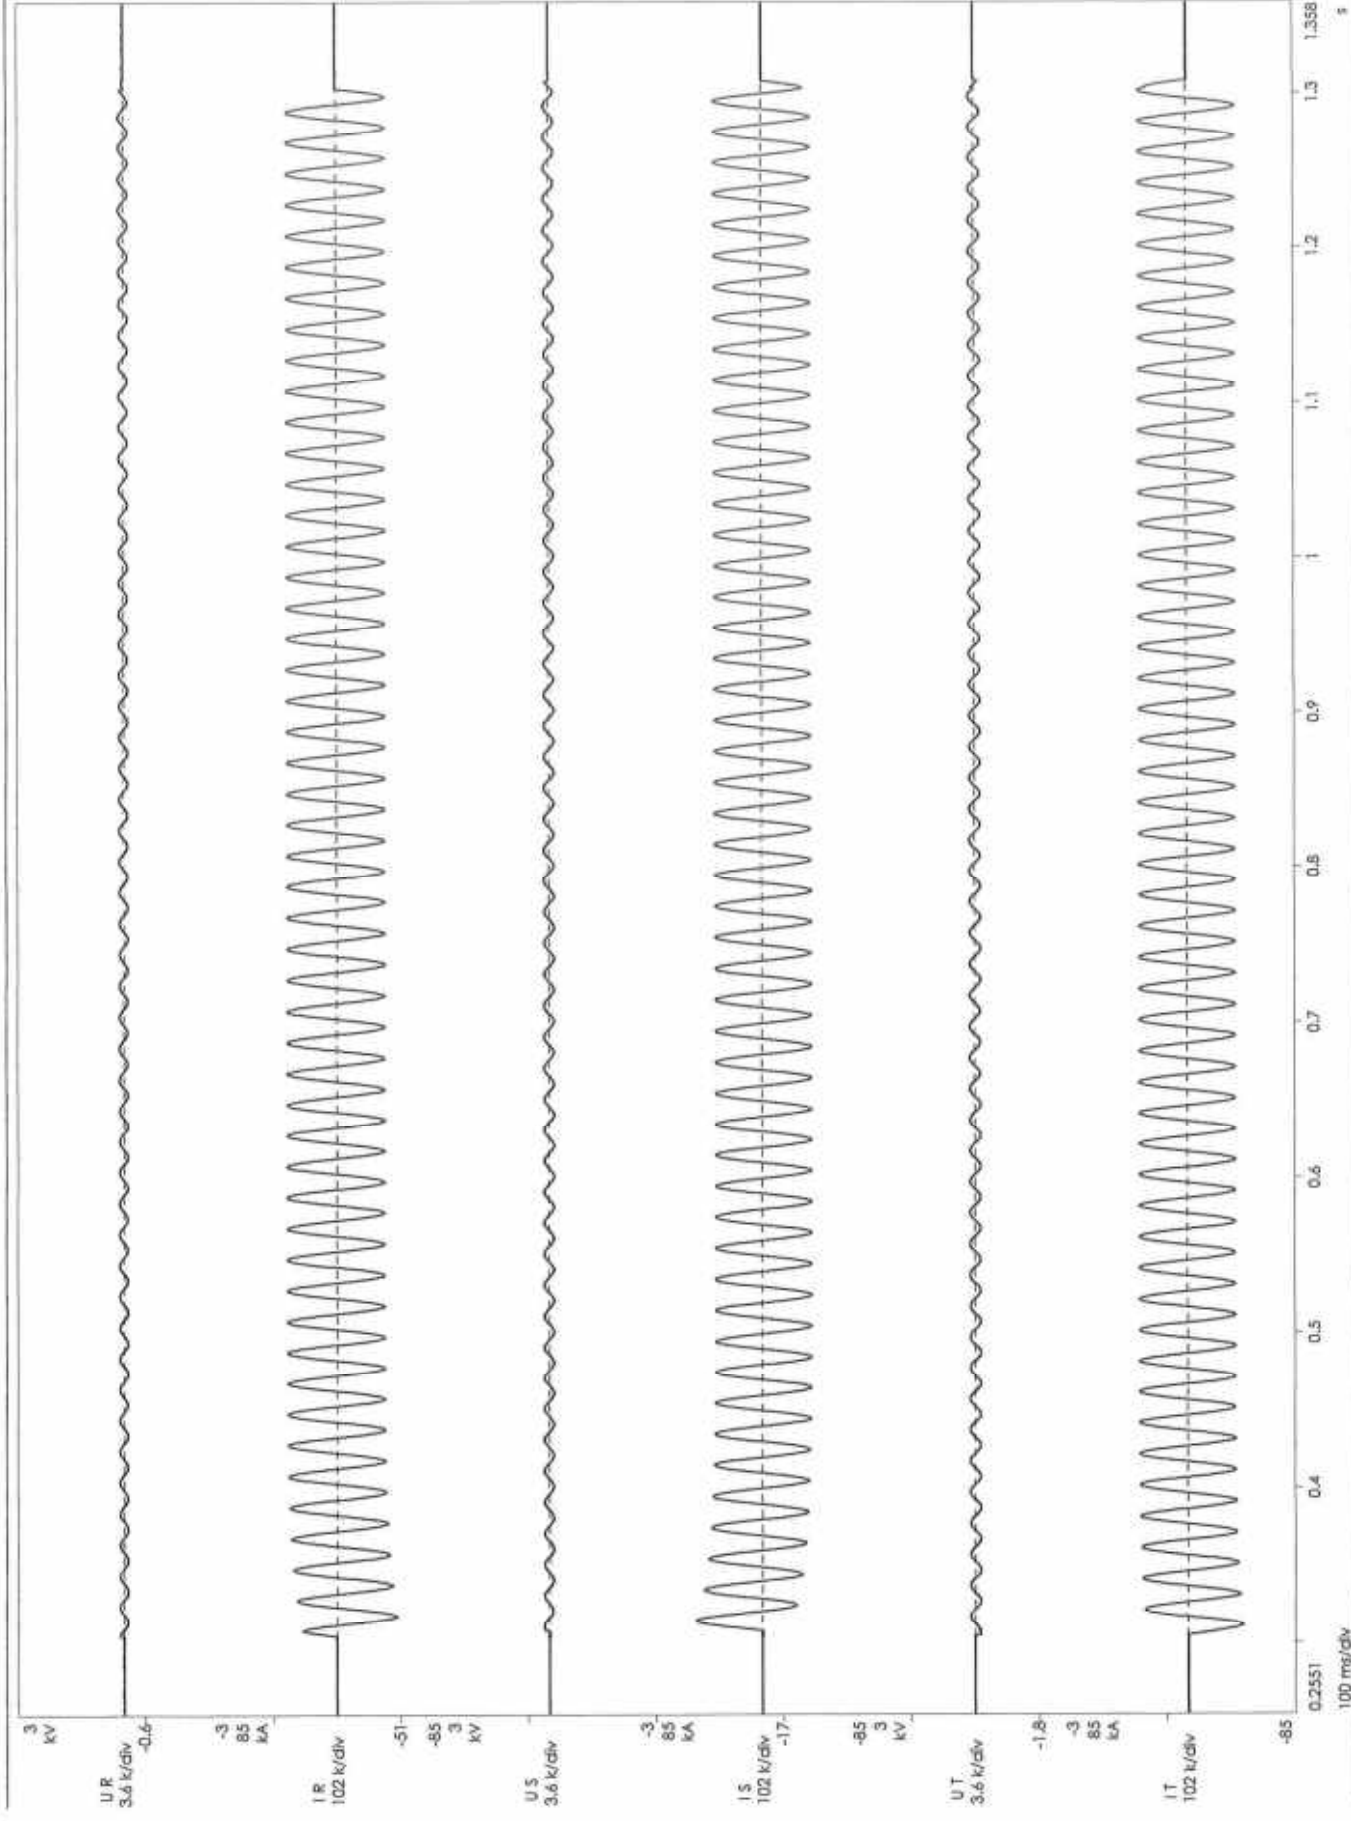
test current

phase R	
R.M.S. value	28.2 kA
peak value	48.2 kA
phase S	
R.M.S. value	27.8 kA
peak value	52.9 kA
phase T	
R.M.S. value	27.8 kA
peak value	43.6 kA
mean value	27.9 kA
duration	1.003 s
I^2t	782 (kA) ² s

t amb = 32.0 °C
