TEST REPORT

N° RP LS 19/164A

DEVICES UNDER TEST: Shrinkable indoor/outdoor terminations for cables

TYPES: ELCOTERM TIS – 2482X/W-3X1-NL-03
ELCOTERM TES – 2484X/W-3X1-NL-03

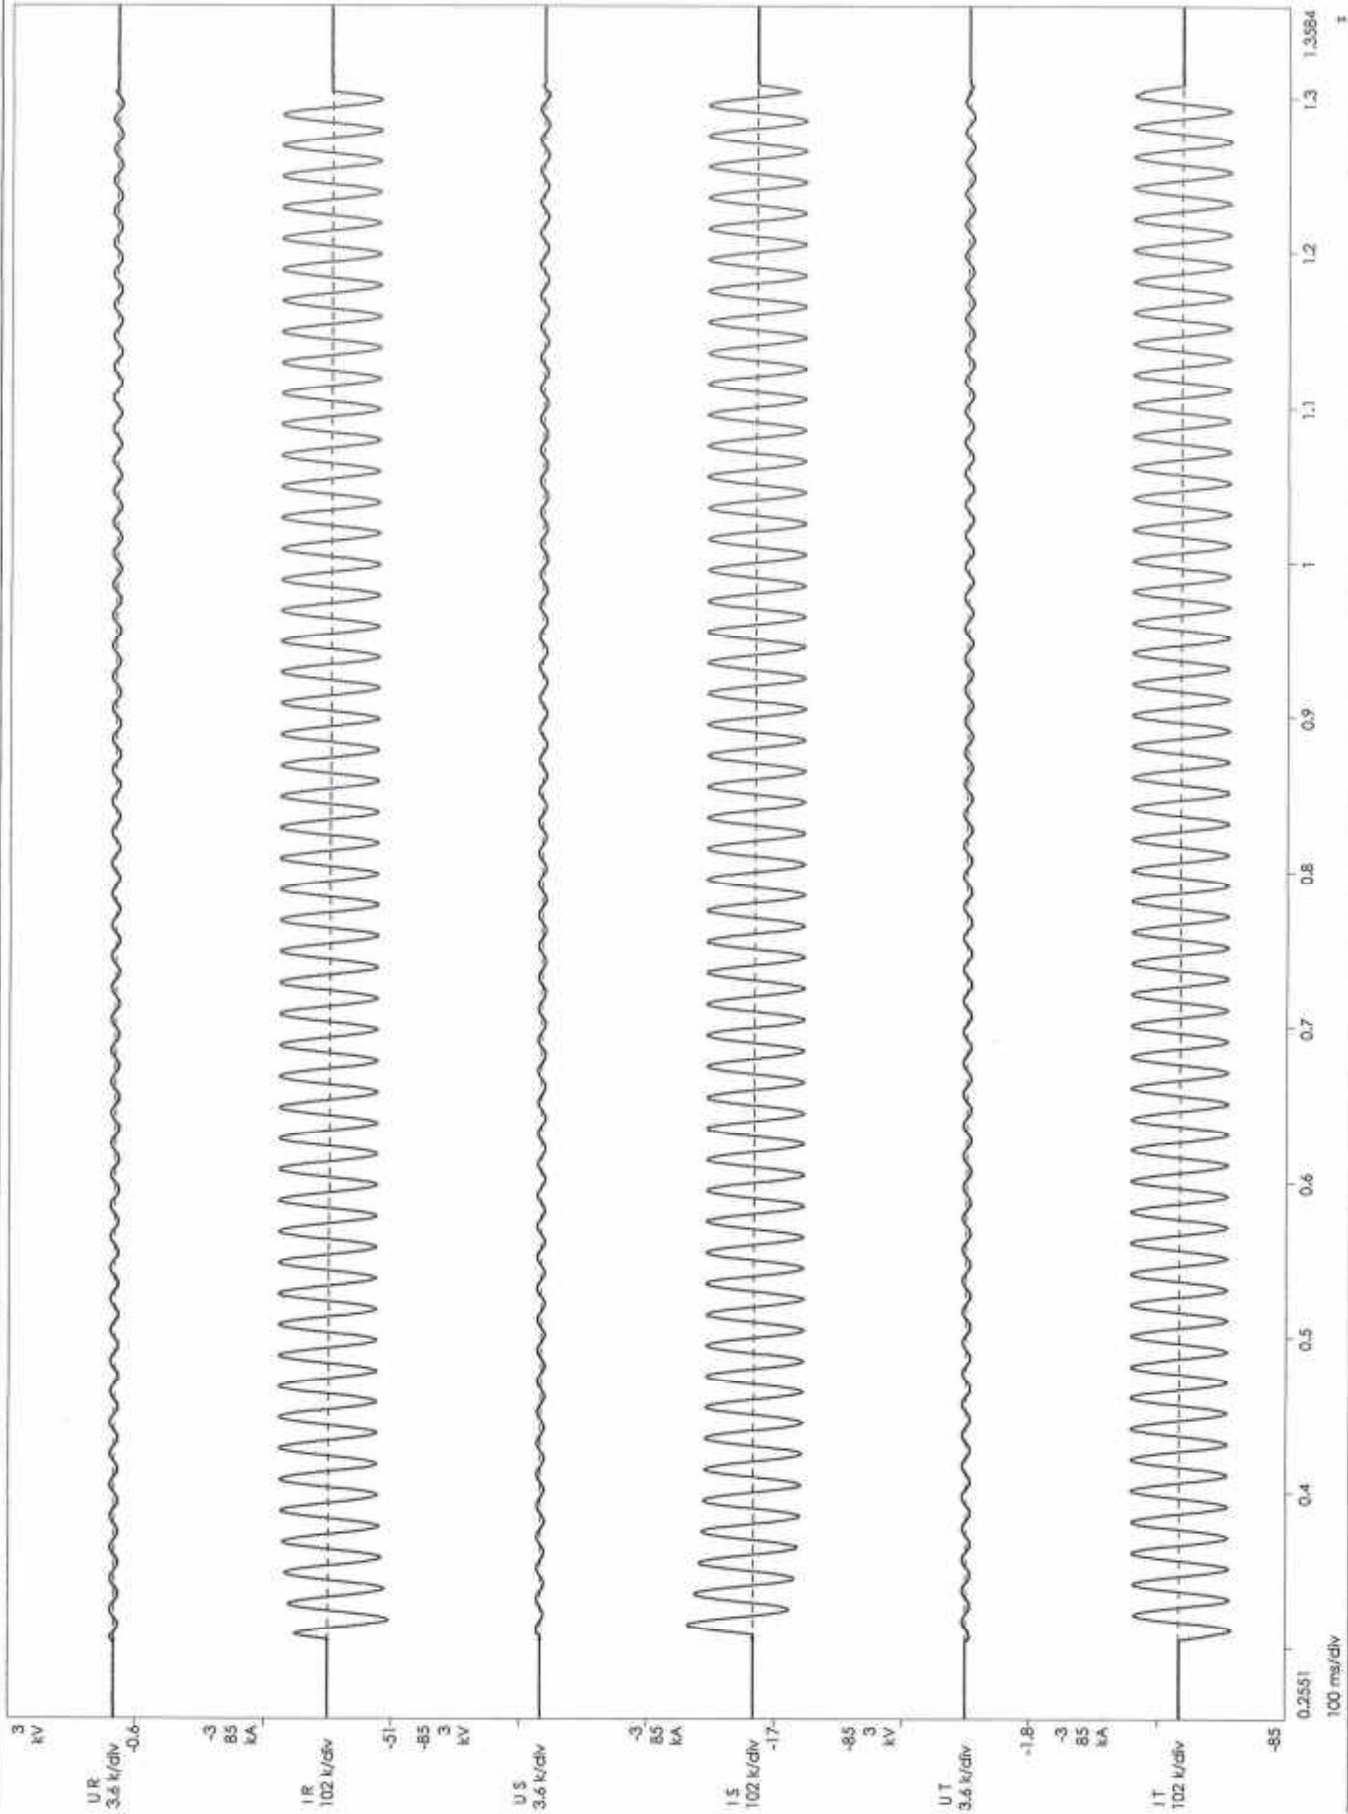
test current

phase R	
R.M.S. value	28.3 kA
peak value	48.8 kA
phase S	
R.M.S. value	27.9 kA
peak value	51.8 kA
phase T	
R.M.S. value	27.8 kA
peak value	41.9 kA
mean value	28.0 kA
duration	1.003 s
i^2t	786 (kA) ² s

$t_{amb} = 32.0 ^\circ C$

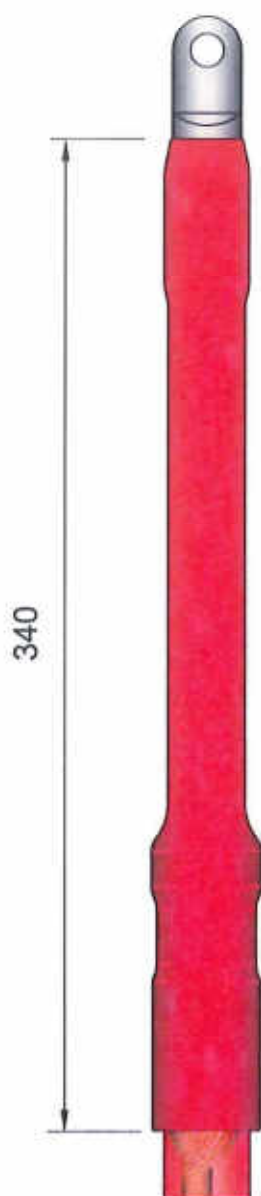
ELCOTERM TIS - 2482X

EXTERNAL DIMENSION

<i>Title</i>
ELCOTERM TES – 2484X EXTERNAL DIMENSION
ELCOTERM TIS – 2482X EXTERNAL DIMENSION

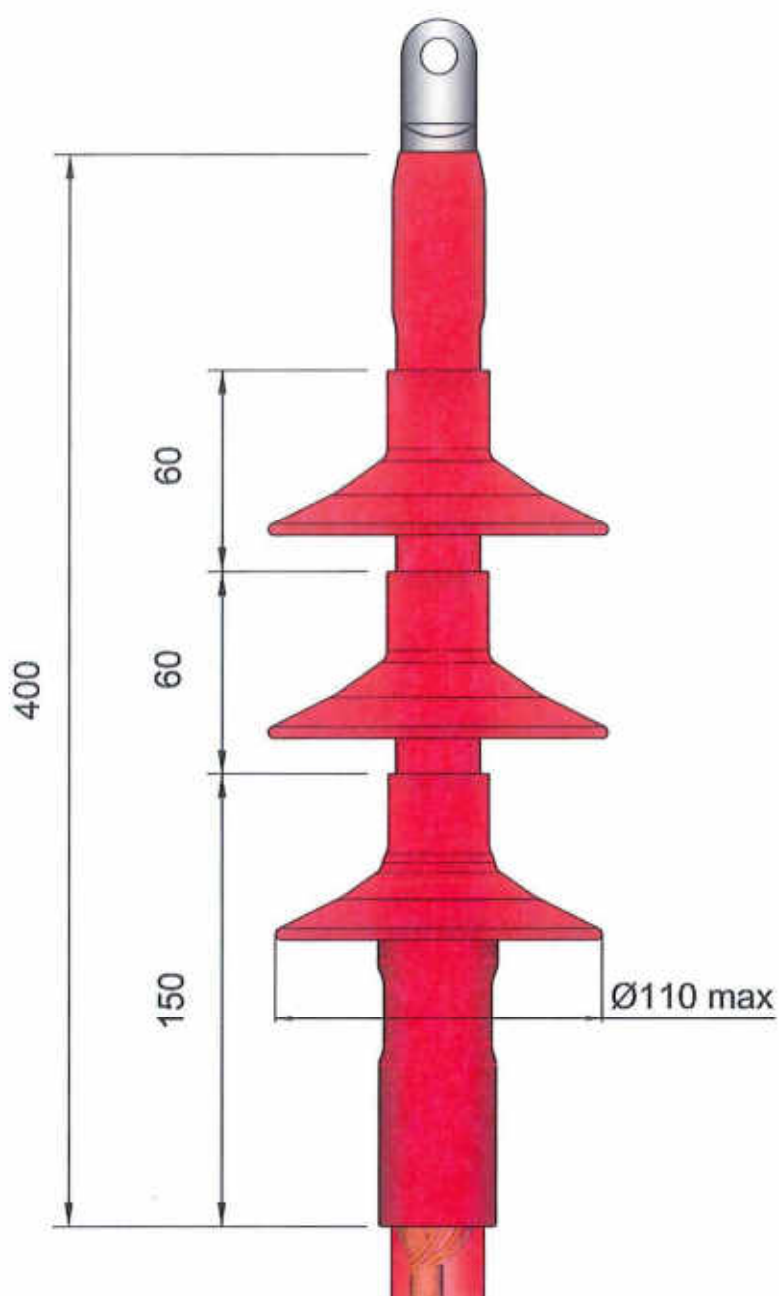
ELCOTERM TES - 2484X

EXTERNAL DIMENSION
