INSPECTION REPORT

B9014922

Subject Inspection to tests on heat shrinkable indoor terminations for single core plastic or rubber insulated cables with wire screen, types:
1- ELCOTERM TIS – 2482X/W-3X1-NL02
2- ELCOTERM TIS – 2482X/W-3X1-NL03
3- ELCOTERM TIS – 2482X/W-3X1-NL05
manufactured by ELCON MEGARAD S.p.A., Via Nazionale, 110 - Arcella (Avellino) – Italy

TEST REPORT

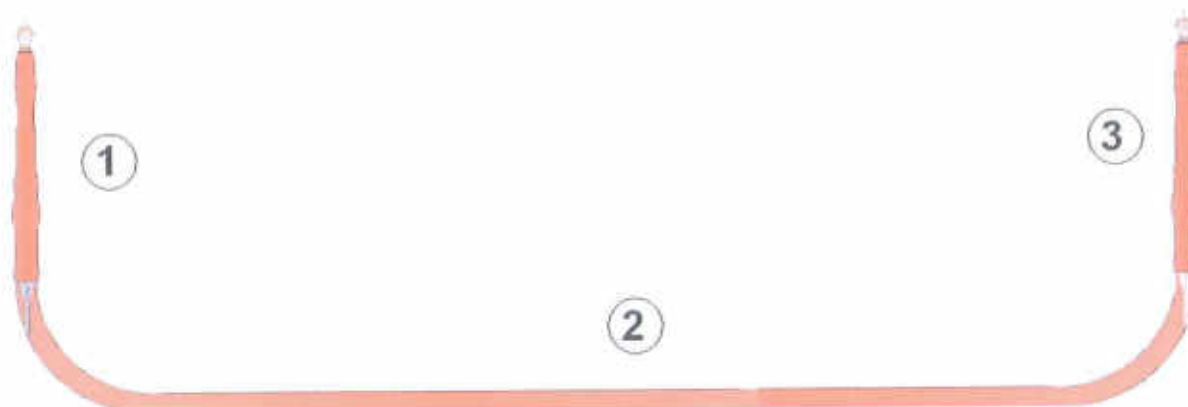
Indicative scheme of cable line

Line	Termination 1	Cable 2	Termination 3
AT033-19	ELCOTERM TIS – 2482X/W-3X1-NL02 Cable Lug TE 16-95mm ²	1x25mm ² Cu	ELCOTERM TIS – 2482X/W-3X1-NL02 Cable Lug PFISTERER 10-95mm ²
AT034-19	ELCOTERM TIS – 2482X/W-3X1-NL03 Cable Lug TE 50-240mm ²	1x95mm ² Cu	ELCOTERM TIS – 2482X/W-3X1-NL03 Cable Lug PFISTERER 50-240mm ²
AT035-19 ÷ AT041-19	ELCOTERM TIS – 2482X/W-3X1-NL03 Cable Lug TE 50-240mm ² Cable Lug PFISTERER 50-240mm ²	1x240mm ² Al	ELCOTERM TIS – 2482X/W-3X1-NL03 Cable Lug NILED 50-240mm ² Cable Lug NEXANS 70-240mm ²
AT042-19	ELCOTERM TIS – 2482X/W-3X1-NL05 Cable Lug TE 630-800mm ²	1x800mm ² Al	ELCOTERM TIS – 2482X/W-3X1-NL05 Cable Lug PFISTERER 300/630-800mm ²

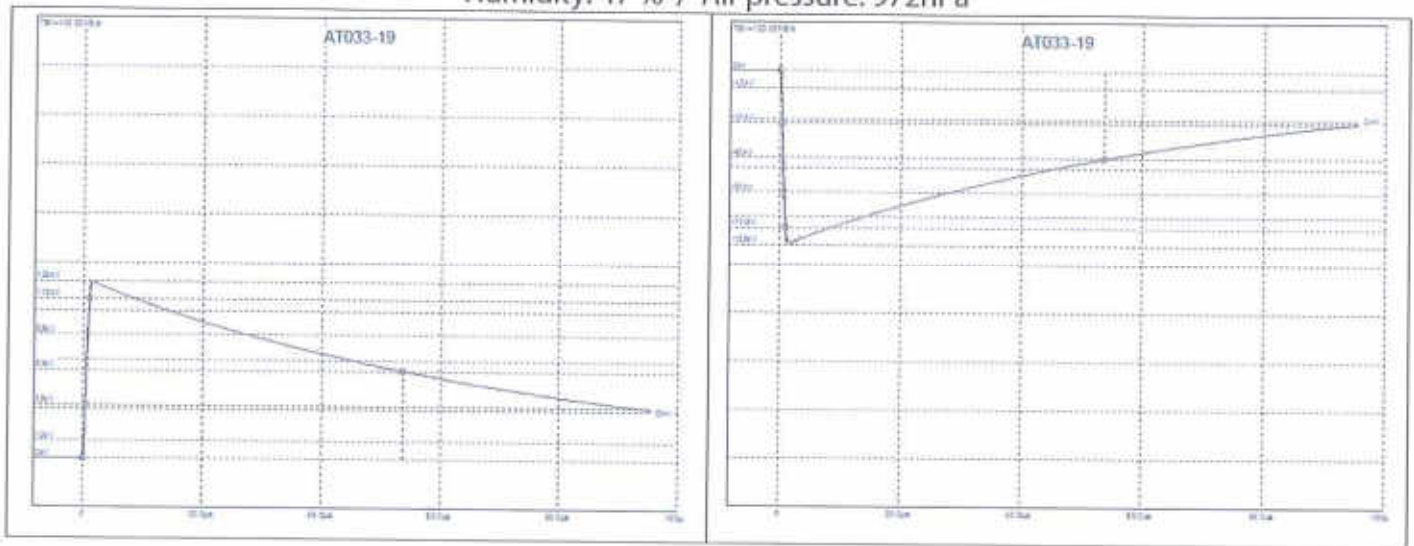
EXAMPLE OF IMPULSE WAVE SHAPE

Humidity: 47 % / Air pressure: 972hPa

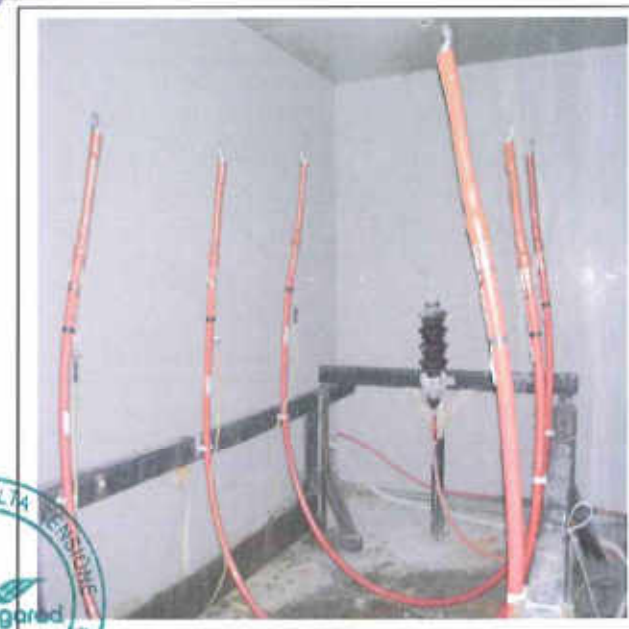
HUMIDITY-TEST

TEST 17	Humidity
Line:	AT039-19 + AT040-19 + AT041-19
Date:	17/05/2019 – 30/05/2019
Test Voltage:	16 kV
Duration:	300 h
Result:	No failure
Note: Water conductivity : 70 ± 10 mS/m.	
Measuring Test Equipment : AT 301 / AT 162

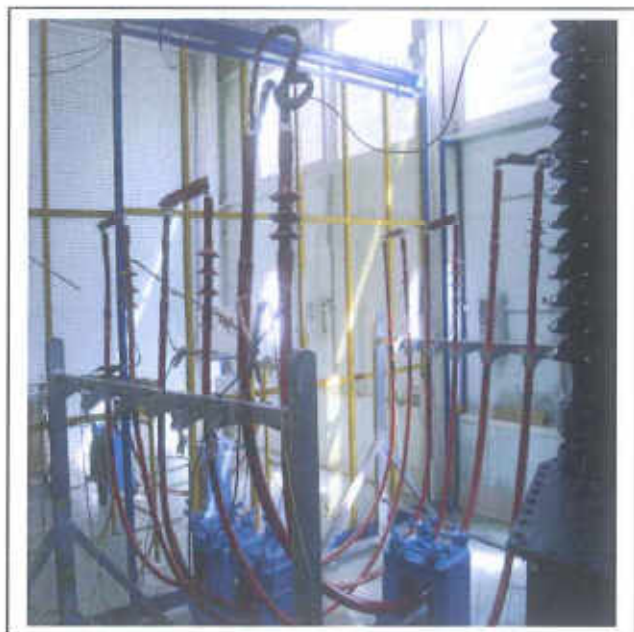
HEATING CYCLE IN AIR -TEST

TEST 04	Heating Cycles voltage in air
Line:	AT034-19 + AT035-19 + AT042-19
Date:	17/05/2019 – 01/07/2019
Test Voltage:	32 kV
Number of cycles:	N° 126
Result:	No breakdown nor flashover
Note: Each heating cycle is completed in 8h and it is carried out in 5h of heating ON with injection of the loading current and 3h heating OFF, with natural cooling of the cable until ambient temperature. During the heating time, the cable conductor keeps a value of temperature 5-10K above the maximum cable conductor (90°C) temperature for at least 2 hours.	
Measuring Test Equipment : AT 228 / AT 229 / AT 181 - AT 183 / AT 280 - AT 289

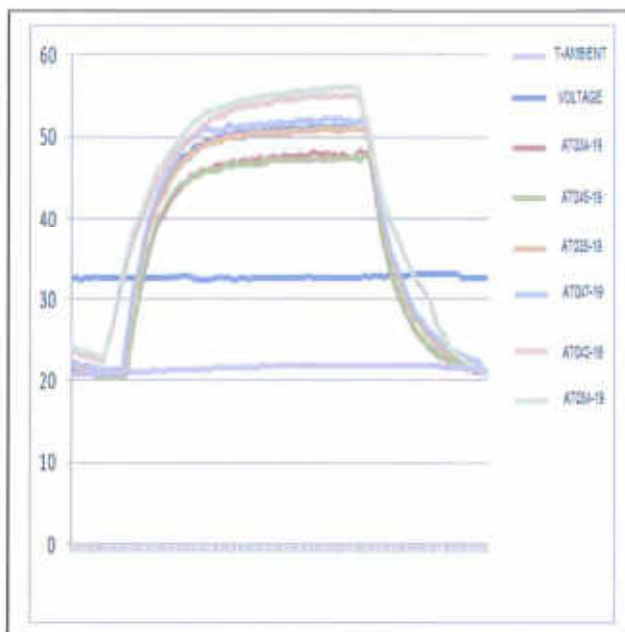
DIAGRAMS FOR HEATING CYCLE IN AIR -TEST

TEST 22	Heating Cycles voltage in air	
Line:	AT033-19	
Date:	17/05/2019 – 21/05/2019	
Test Voltage:	32 kV	
Number of cycles:	N° 12	
Result:	No breakdown nor flashover	
Note: Each heating cycle is completed in 8h and it is carried out in 5h of heating ON with injection of the loading current and 3h heating OFF, with natural cooling of the cable until ambient temperature. During the heating time, the cable conductor keeps a value of temperature 5-10K above the maximum cable conductor (90°C) temperature for at least 2 hours.		
Measuring Test Equipment : AT 228 / AT 229 / AT 181 - AT 183 / AT 280 - AT 289
